Upgrading the footpaths and surrounding environment on Midsummer Common: a summary of our recommendations

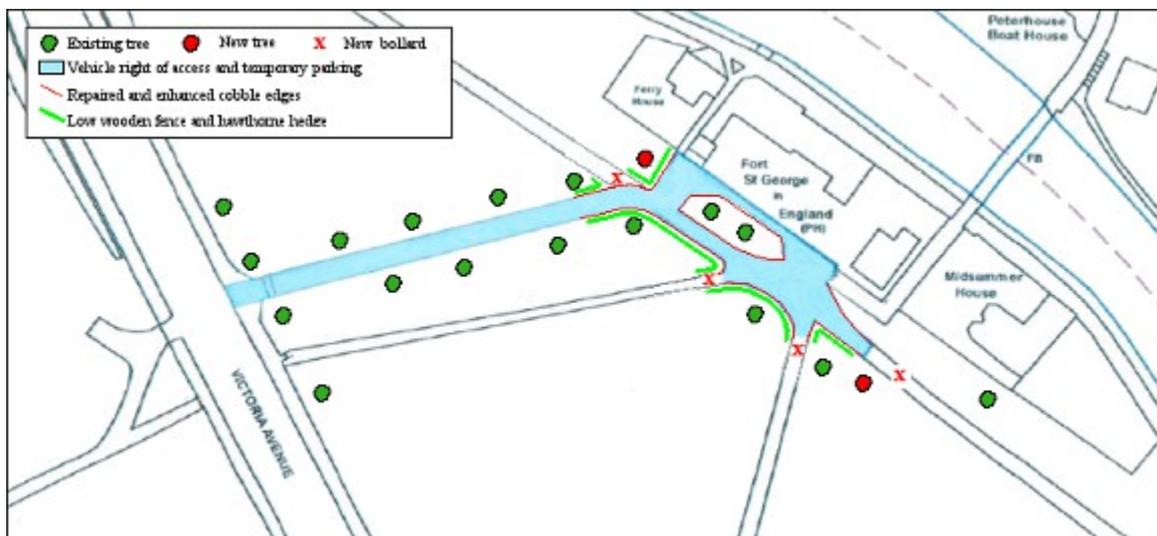
1. Environmental enhancement of the Fort St George area. The continuing problem of illegal driving and parking around the Fort St George pub and Midsummer House restaurant has resulted in widespread environmental degradation of the Common. Parked vehicles are an eyesore and barrier to pedestrian and cycle movements. Ways must be found to keep vehicles within the designated area and not to outstay their welcome. Whilst the paths are generally fit for purpose, environmentally sensitive and high quality measures must be taken to prevent vehicles leaving the paths and driving and parking on the grass.

- a) Restoring and extending the cobbled edges to the paths at the most vulnerable corners;
- b) Planting some low hedging and protective fencing to discourage illegal driving and parking on the grass;
- c) Planting two trees to reinforce the driving restrictions;
- d) Pruning the trees immediately outside the FSG to ease movements and improve views across the Common;
- and
- e) Installing removable bollards along cycle/pedestrian routes to stop vehicles exiting over the grass.

A detailed plan of our proposal is shown below.

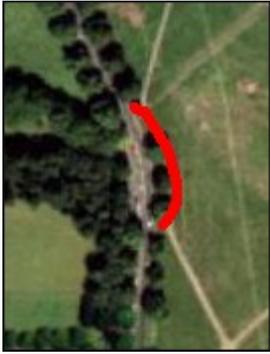
2. The footpath linked to Victoria Avenue. This short narrow footpath is in constant use by both pedestrians and cyclists. Its surface has many pot holes, puddles and gravel areas which, when coupled with heavy traffic, makes it unsafe. The edges are fragmented and indistinct. Poor drainage results in large puddles along the edges. We **recommend** that this path be:

- a) Resurfaced with a lower camber, improved edging and well keyed-in grass verges and drainage; and
- b) A sign should be placed on the railings at the entrance to the Common asking cyclists to slow down.

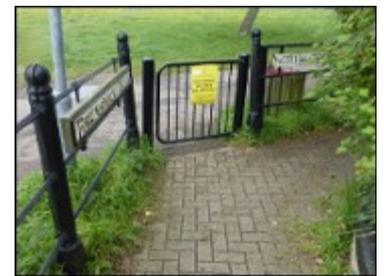
3.1 The intersection at B. Three footpaths used by pedestrians and cyclists meet at a pedestrian gate leaving North Terrace and Brunswick Walk. The downhill slope from Fair Street encourages cyclists to go fast. The footpaths are in bad condition at this junction, utility manhole covers break the surface and visibility is impaired by the corner buildings. It is dangerous to walk through the gate, especially at night, because of unsighted cyclists.

We **recommend** that the layout of this junction be fundamentally reviewed:

- a) The path should be lightly cambered and curved further away from the gate (at B) allowing pedestrians who wish to enter the Common a place to wait until it is safer to cross the path;
- b) Signs should be placed on the railings asking cyclists to slow down in this pedestrian area;
- c) The awkward junction of paths CB/DB should be improved by adding a little more tarmac to round the corner;
- d) The verge should be well integrated by placing soil and grass seed at least 1 to 1.5m wide along both sides and compacted so that it lies flush with the final tarmac surface, allowing any overtaking bikes an easy run-off (as has been achieved on Coe Fen behind the Leys School);
- e) Adjacent manholes should be made flush with the final tarmac surface and grass verge; and
- f) A further tree could be added along section BD.

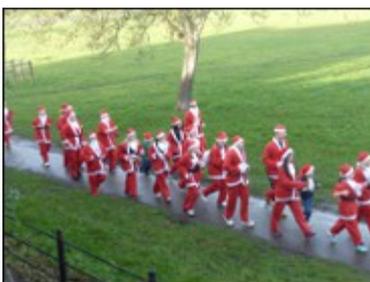
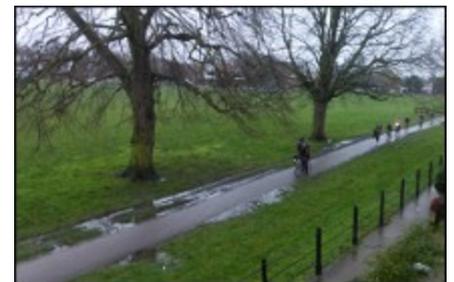
3.2 The stretch from B to A. This is a long, narrow footpath close to North Terrace that is overcrowded with walkers and cyclists often brought into conflict with each other. There is a natural tendency for both to stray onto the adjoining grassland which is often waterlogged. Water collects there because the footpath as a structure impedes the natural flow of surface water on the Common. In many areas grassland is also compacted, mainly by the Council's litter collection lorry that makes its daily journey straddling the path.

Water collects there because the footpath as a structure impedes the natural flow of surface water on the Common. In many areas grassland is also compacted, mainly by the Council's litter collection lorry that makes its daily journey straddling the path.

We **recommend** that serious thought be given to rebuilding this footpath:

- a) Improved grassed verges flush with the final tarmac edges (minimum 1-1.5m wide) would ease the drainage problem right next to the path;
- b) Enhanced surface finish. Building on a floodplain is not easy. The 2009 Management Plan says that paths surfaced with tarmacadam "suits the Common as it is hard-wearing, has some degree of flexibility and

requires a shallower construction than a paved path. A top dressing of gravel chippings, as suggested in the 2001 Conservation Plan, would soften the appearance of the footpaths whilst retaining their practicality". This may not be practical for a cycle route but an improved surface finish is essential. No road markings should be used on the Common;

- c) Widening the path. There is a strong case for widening this very busy path (currently 1.5-1.8m wide.) to an absolute maximum of 2.5m. But it is important to recognise that there are statutory restrictions on what can be done with footpaths on "common land" such as Midsummer Common. The *Commons Act 2006* prohibits the resurfacing of "common land" without the Secretary of State's consent. Resurfacing means "the laying of concrete, tarmacadam, coated roadstone or similar material, but does not include repairing an existing surface of land made of such material". This might imply that the "widening" of footpaths requires ministerial consent involving public consultation and likely objections;

- d) Tree preservation. When widening the path great care is needed to avoid the root zones of existing specimen trees. Therefore, the final path should undulate lightly through the Common and as such set a new characteristic of the area and create more interest when using it; and

- e) City Council refuse collection vehicles should avoid damaging Common paths and make collections in a different way. A proper workable route should be developed to empty the bins in an ergonomically efficient way without damage to the Common - particularly where this is undertaken on a daily basis.

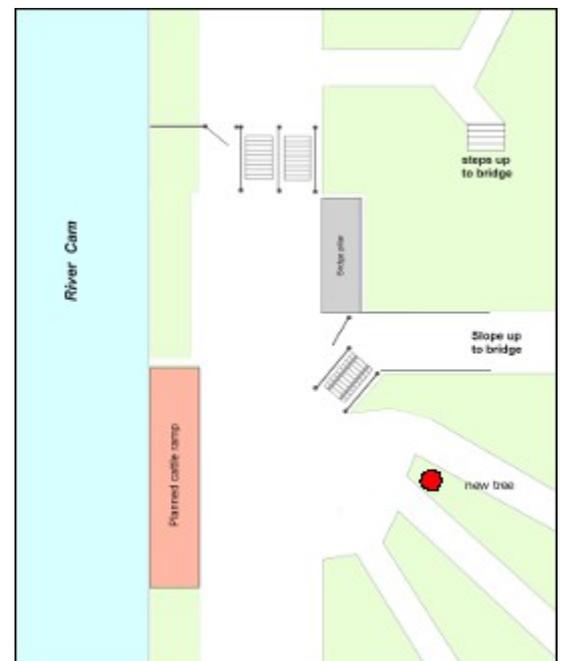
The current junction layout is hazardous. Pedestrians and push chairs must cross the bike lanes to use the gates. Cyclists travelling in both directions along the river bank must cross the same cattle grids twice. Many posts in the path give a challenging barrier to movement. Those coming off the bridge are fed at right angle past a blind spot straight into this two-way traffic. Users, cyclists in particular, have asked for improvements to the layout in order to ease congestion and improve safety. However, where mixed transport must share a space it might be better not to free things up so everyone is obliged to slow down and be prepared to give way.

We **recommend** a fundamental review of this intersection. One might consider (see sketch plan on right):

- a) A single gate for pedestrians (in line with the new gate installed at Walnut Tree Avenue);
- b) Two cattle grids in parallel for cyclists travelling in opposite directions (in line with the grids installed at Walnut Tree Avenue). Cattle grids to have a proper internal ramp to enable easy escape for any trapped wildlife;
- c) To reduce conflicts for those coming off the bridge, the base of the slope might be redirected away from the cross traffic and a cattle grid with pram irons and pedestrian gate inserted (as on the footbridge next to the Fort St George pub). Space can be reserved for the City Council's proposed cattle ramp;
- d) Planting of a tree and cattle guard to the rear of the new litter bins to integrate these large features better into the Common landscape; and
- e) At all times, high quality design detailing should be adhered to.
