Upgrading the footpaths and surrounding environment on Midsummer Common: a summary of our recommendations

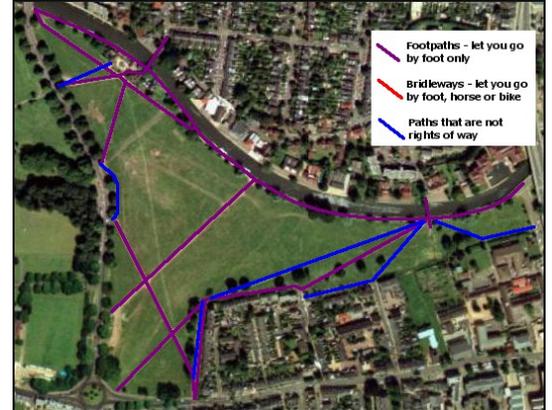
1. Environmental enhancement of the Fort St George area. The continuing problem of illegal driving and parking around the Fort St George pub and Midsummer House restaurant has resulted in widespread environmental degradation of the Common. Parked vehicles are an eyesore and barrier to pedestrian and cycle movements. Ways must be found to keep vehicles within the designated area and not to outstay their welcome. Whilst the paths are generally fit for purpose, environmentally sensitive and high quality measures must be taken to prevent vehicles leaving the paths and driving and parking on the grass.

The Council recently negotiated rights of access and parking with the pub owner and this should be the starting point. We **recommend**:

- a) Restoring and extending the cobbled edges to the paths at the most vulnerable corners;
- b) Planting some low hedging and protective fencing to discourage illegal driving and parking on the grass;
- c) Planting two trees to reinforce the driving restrictions;
- d) Pruning the trees immediately outside the FSG to ease movements and improve views across the Common;
- and
- e) Installing removable bollards along cycle/pedestrian routes to stop vehicles exiting over the grass.

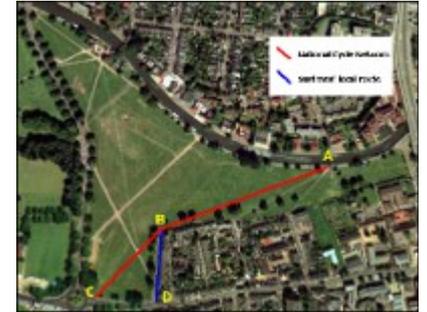
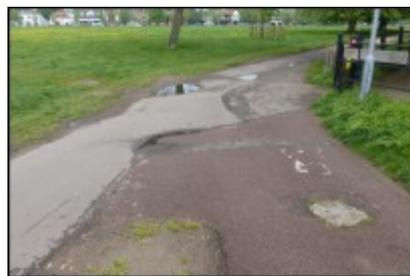
3. The footpath from Cutter Ferry Bridge to Maids' Causeway. Heavy traffic and conflicts are particularly evident on the footpath from Cutter Ferry Bridge (A) to Maids' Causeway (C and D) - see map to right. The stretch from A to C is part of the National Cycle Network; the stretch from B to D is a Sustrans local route. Only the stretch from B to C is a Public Right of Way. There are 3 major problems areas associated with this footpath: the intersection at B, the stretch from B to A, and the intersection at A.
